R9R Discussion Regarding Interior Flooding At The Byron Carlyle Theater.
(Tourism, Culture & Economic Development)

**BYRON CARLYLE THEATER
500 71ST STREET
MIAMI BEACH, FLORIDA**

MARCH 4, 2016

LIMITED CONDITIONS ASSESSMENT REPORT RELATIVE TO INTERIOR FLOORING

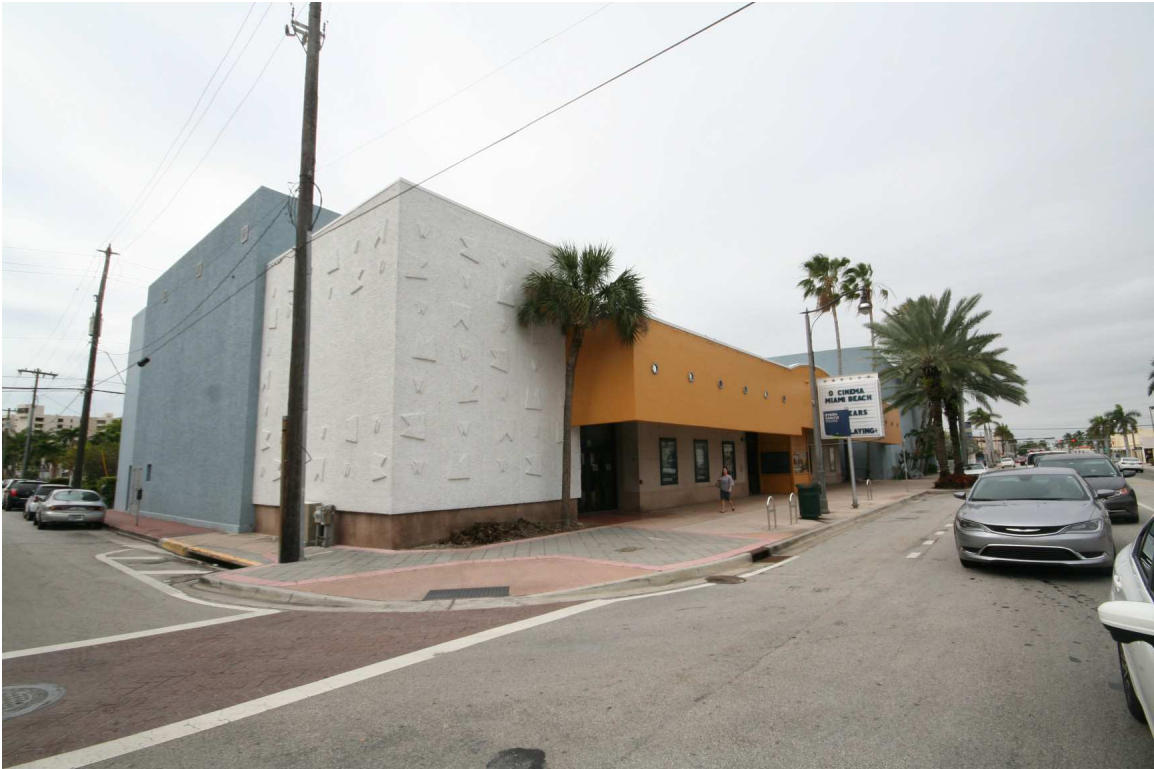
PHOTOGRAPH NO. 1
NORTHEAST CORNER OF BUILDING
(NOTE STREET, SIDEWALK & DOOR ELEVATIONS. NOTE PROXIMITY OF STREET DRAINS)

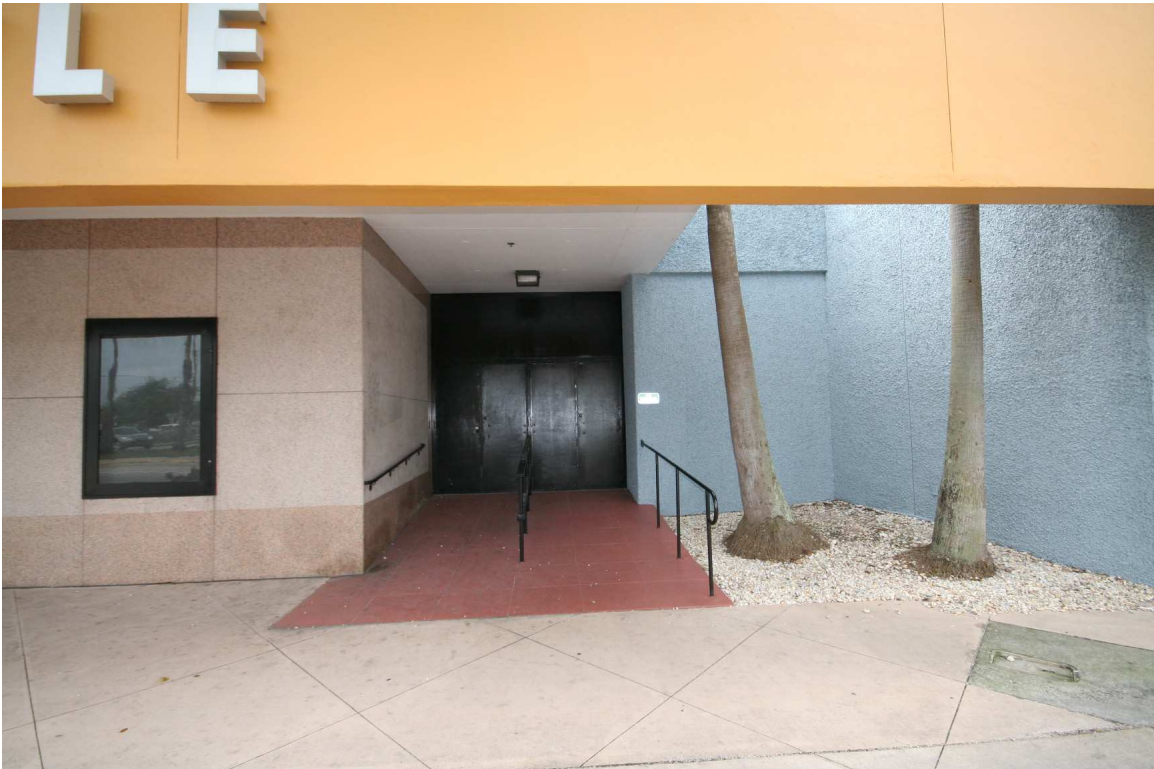
PHOTOGRAPH NO. 2
NORTH SIDE EXIT DOORS

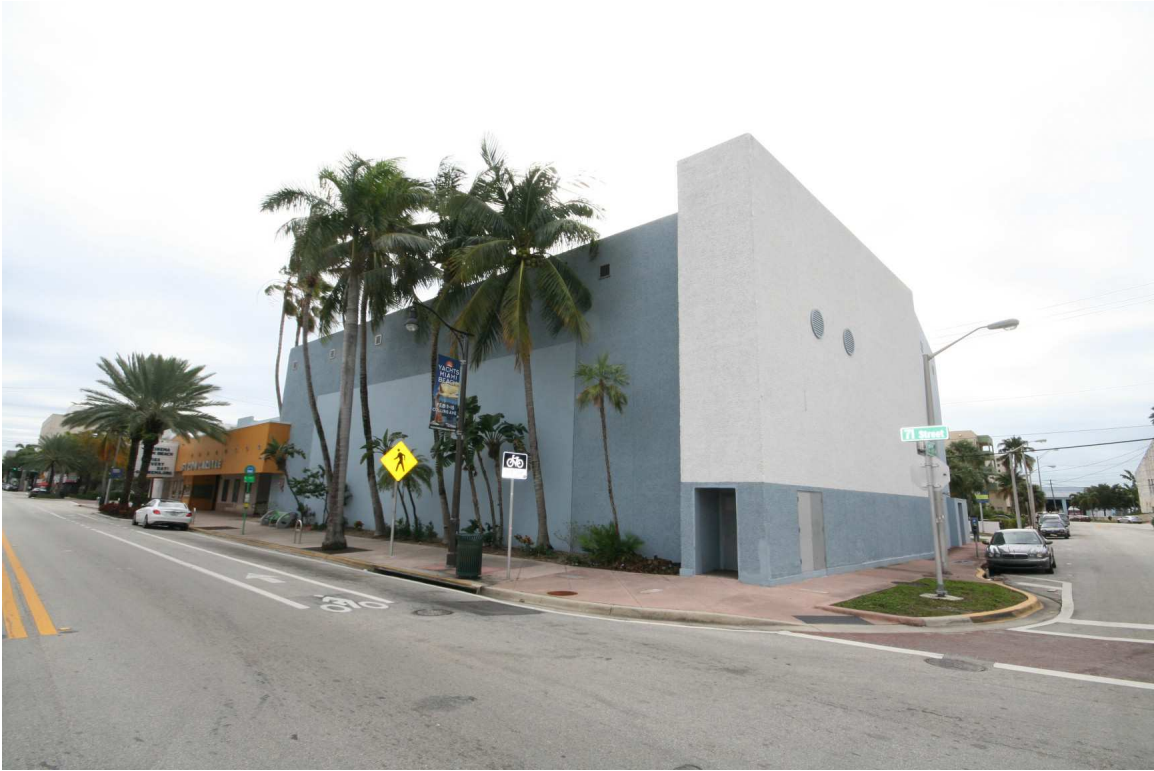
**PHOTOGRAPH NO. 3
NORTHWEST CORNER OF BUILDING
(NOTE STREET, SIDEWALK & DOOR ELEVATIONS. NOTE PROXIMITY OF STREET DRAINS)**

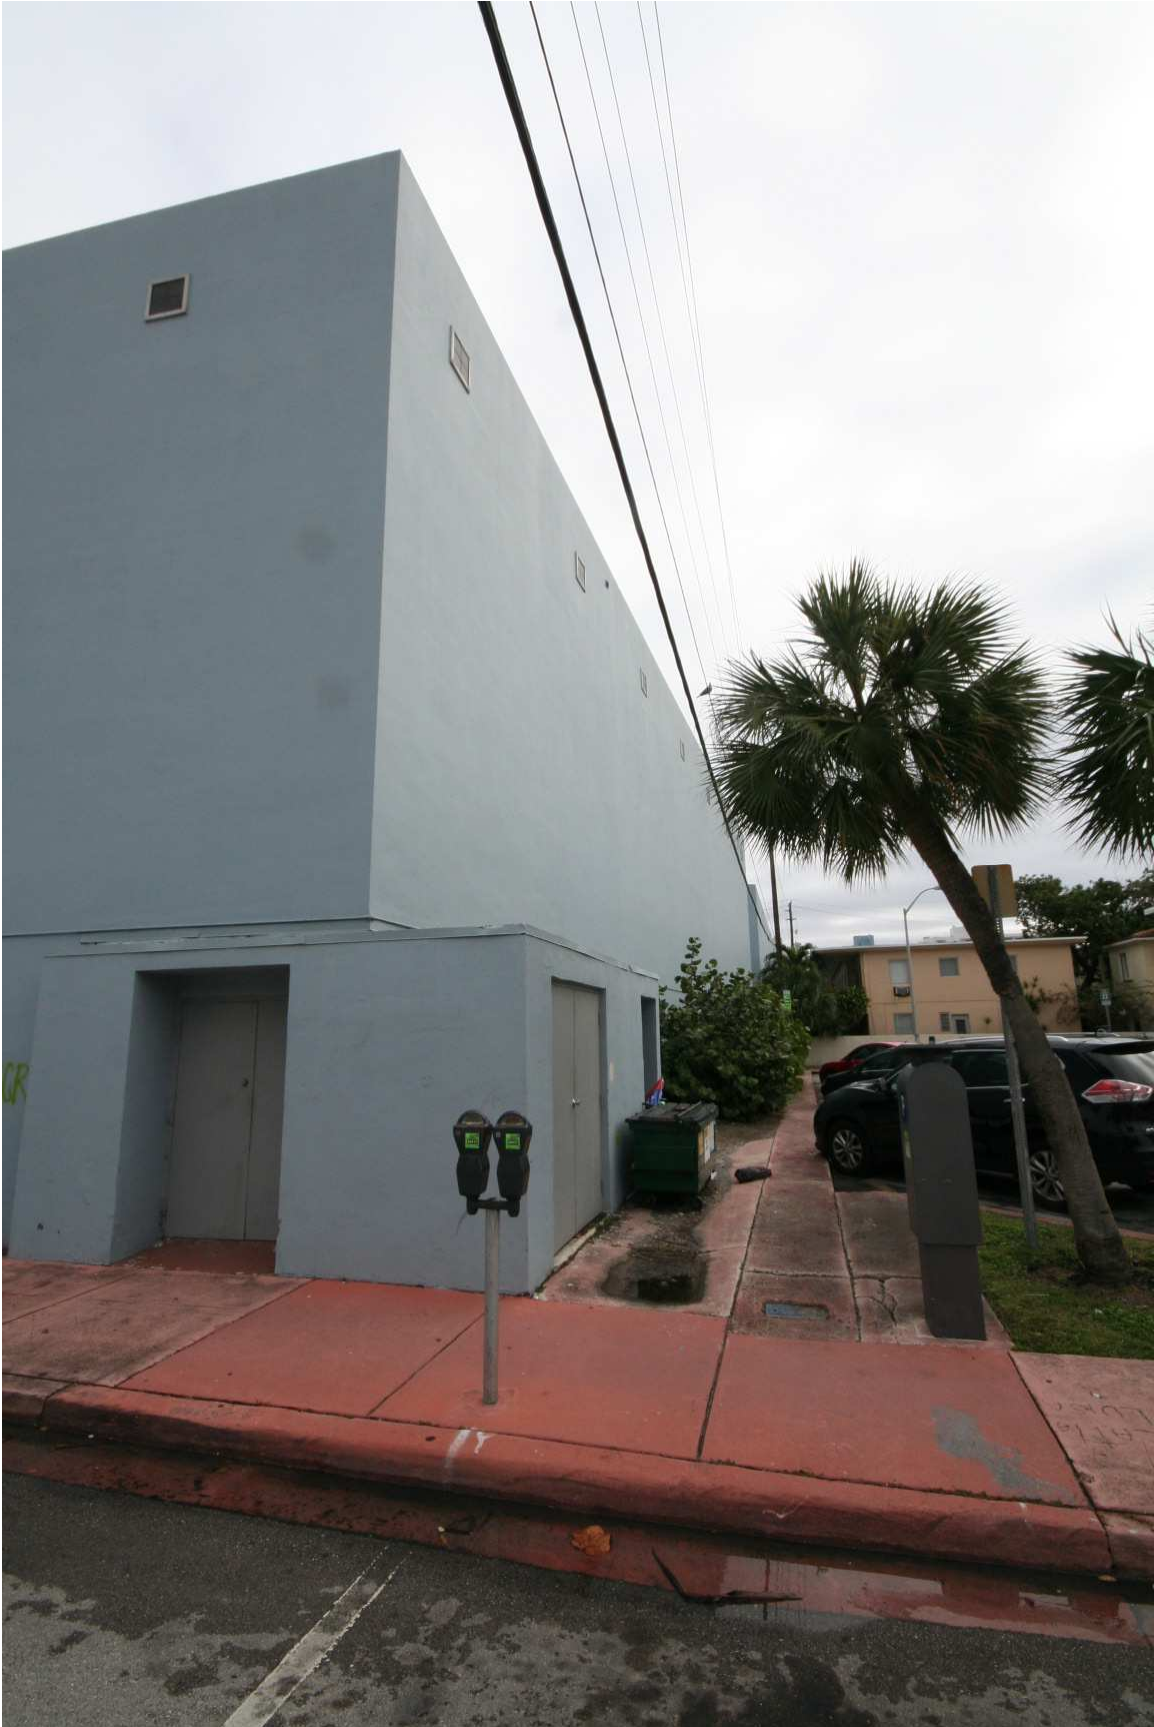
**PHOTOGRAPH NO. 4
SOUTHWEST CORNER OF BUILDING
(NOTE SIDEWALK AND DOOR ELEVATION)**

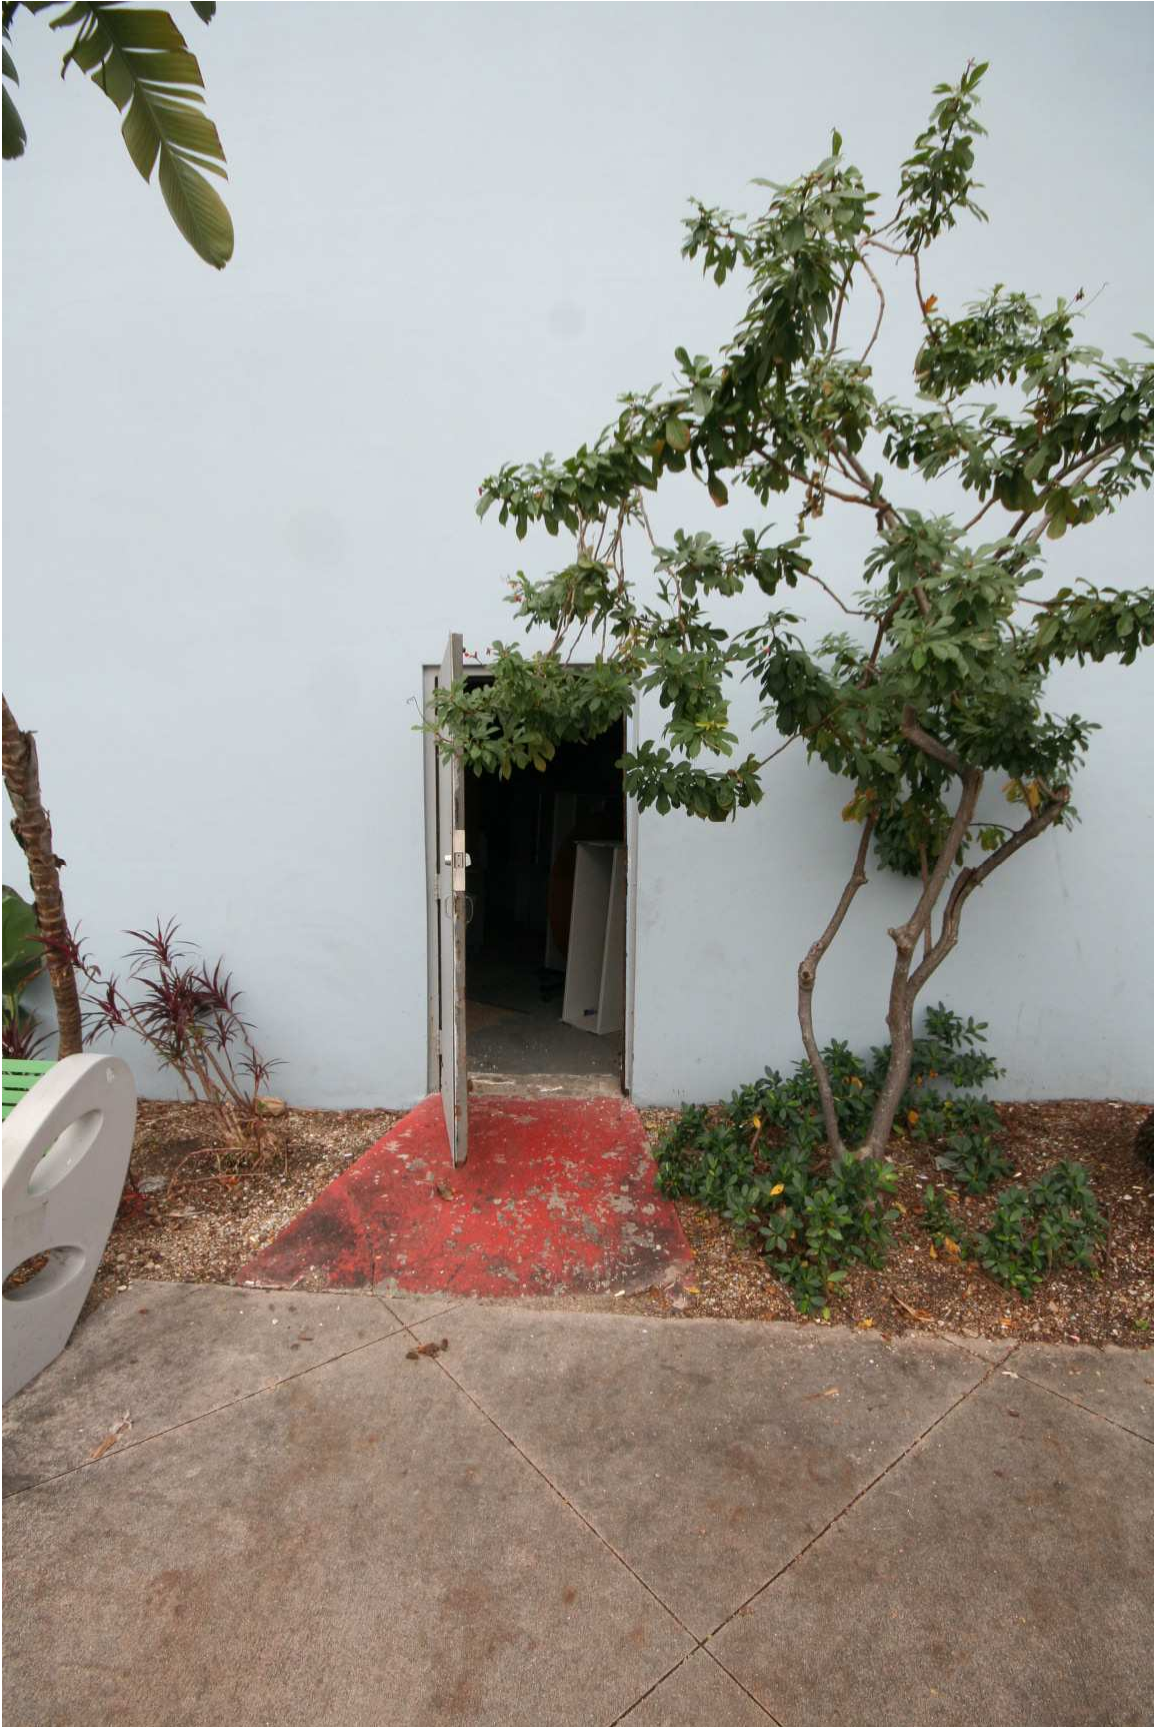
**PHOTOGRAPH NO. 5
NORTH SIDE EXIT DOOR
(NOTE THRESHOLD ELEVATION RELATIVE TO SIDEWALK)**

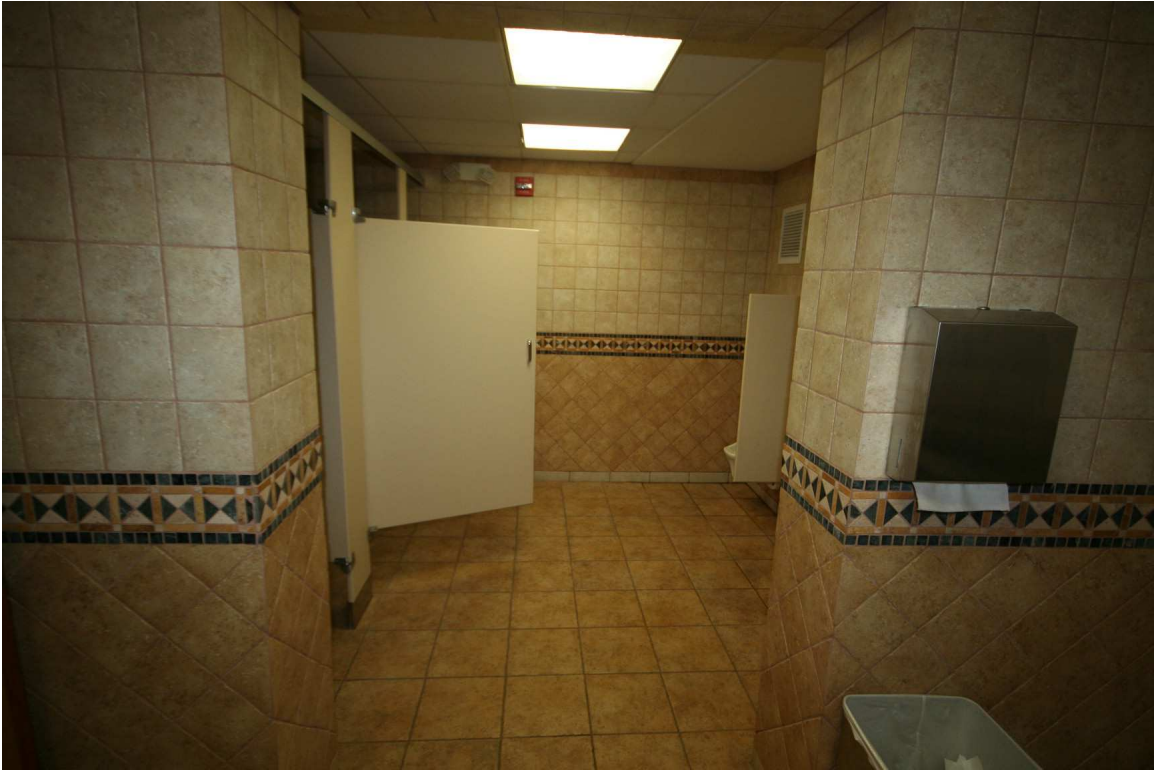
The writer conducted a brief telephone interview with the current theater manager. The manager reported that up to a "few inches" of water accumulated on the floor of the eastern restrooms at high tide during the past king tide cycle of October, 2015. The manager reported that portable pumps were used to lower the water level in the restroom area during periods of flooding. The manager also reported that he observed tidal flooding in the streets around the theater up to the curbs, but not onto/over the sidewalks.

Based on our visual observations and based on the verbal report from the current building manager, it appears that the restroom area at the east end of the building and the low points of the west side auditoriums regularly flooded around high tides during the cycle of king tides this past October, 2015. Water depths up to a few inches were reported. Tidal flooding in the adjacent streets up to the sidewalk curbs was reported. Based on our observations, it appears that the restroom area floor and the low points of the west side auditoriums are significantly below the high tide elevation during the cycle of king tides this past October, 2015. The drawings for the original construction also indicate a storage area, mechanical room and electrical room in the southeast corner of the building to be below exterior grade elevation (but several inches higher than the restroom area floor).

**PHOTOGRAPH NO. 6
(EXISTING RESTROOM)**

1. **Raise Existing Restroom Floor**

If there is sufficient headroom to the structure above, one might consider raising the existing restroom. To accomplish this, however, would require casting say a six-inch thick concrete topping on the floor. This, in turn, would essentially require a complete demolition and reconstruction of the restrooms. Such construction would be fairly expensive. In addition, the raised level of floor may soon be below groundwater elevations.

2. **Abandon Existing Restrooms and Reconstruct Restrooms Elsewhere**

If an area is available elsewhere, at the main ground-floor level, new restrooms could be constructed. Such new restrooms, however, would still likely be well below the current Design Flood Elevation (DFE). The abandoned restroom area would also still be subject to flooding with its negative effects. Therefore, it would be appropriate to raise the restroom floor with concrete topping to prevent flooding. An appropriate vapor barrier or waterproofing system should be included to prevent water vapor migration into the space.

3. Demolish Existing Restrooms and Reconstruct with “Dry-Floodproofed” Construction

It is allowed to “dry-floodproof” non-residential uses. In the case of the present location of the restrooms, dry-floodproofing would require a complete demolition of the existing non-structural construction in the area. It would also require removal of the existing concrete floor slab. It would also likely require removal of existing masonry walls around the restroom area and replacement with appropriately reinforced concrete or masonry walls. The floor slab would need to be replaced with a structurally reinforced concrete slab capable of resisting the DFE flood. Tension piles (to resist upward loads) would also be required at some spacing. The new slab and all perimeter walls up to the DFE would need to be waterproofed. Any openings below the DFE would need to be protected with appropriately designed flood panels. Sanitary drain pipes would need to be equipped with backflow preventers to prevent reverse flow through the pipes into the space. It would also be prudent to provide an automatic sump pump.

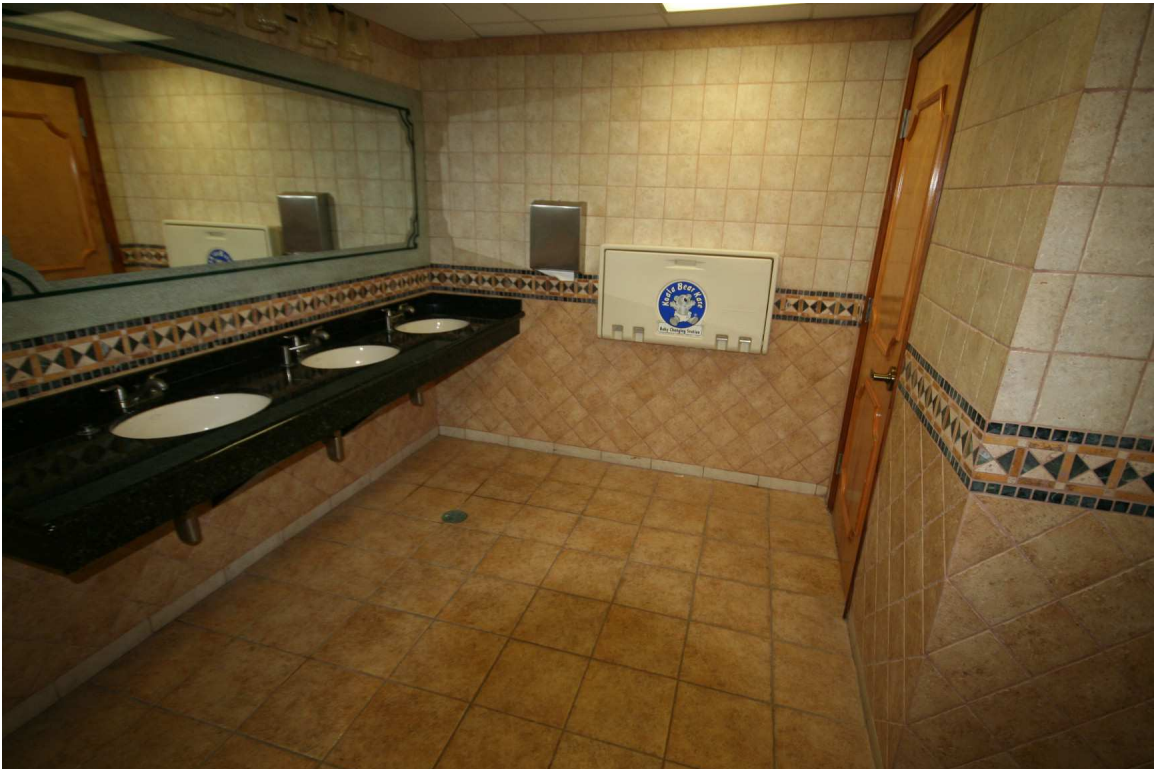
**PHOTOGRAPH NO. 7
(EXISTING RESTROOM)**

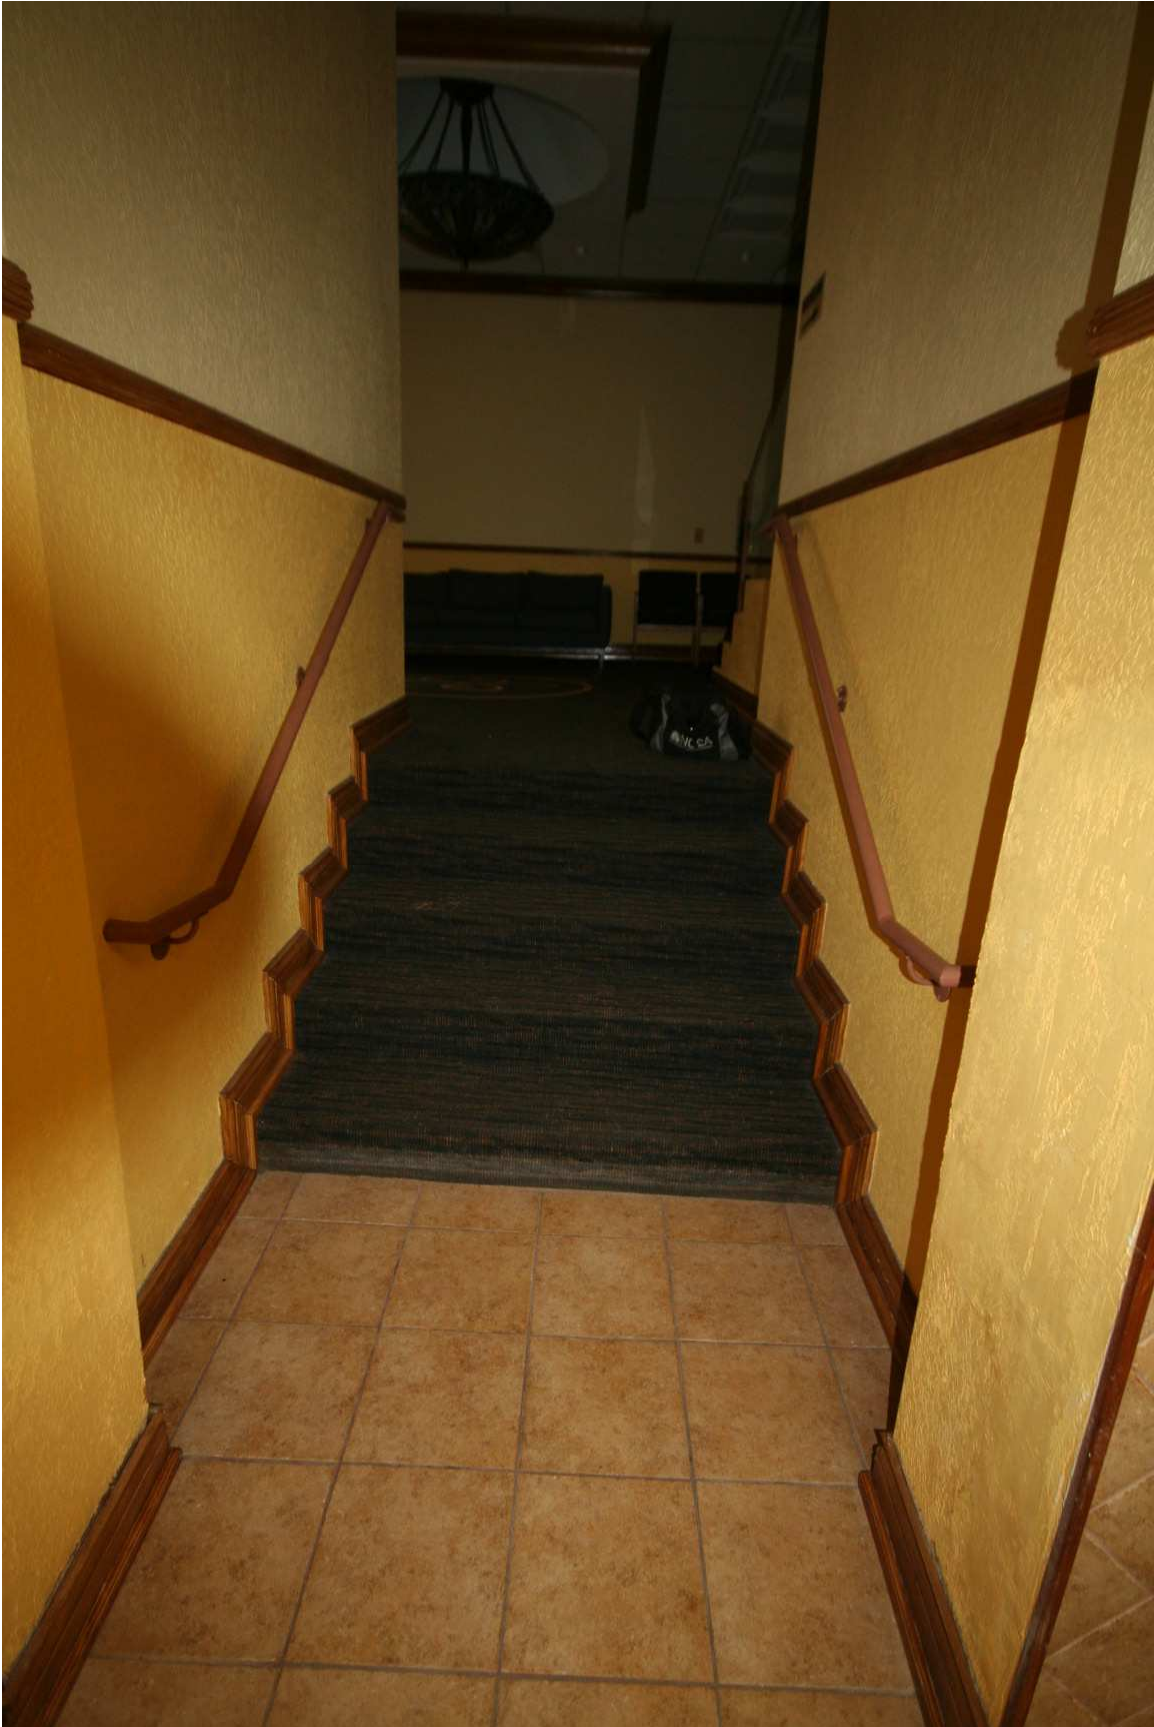
**PHOTOGRAPH NO. 8
STEPS FROM LOWER RESTROOM UP TO LOBBY**

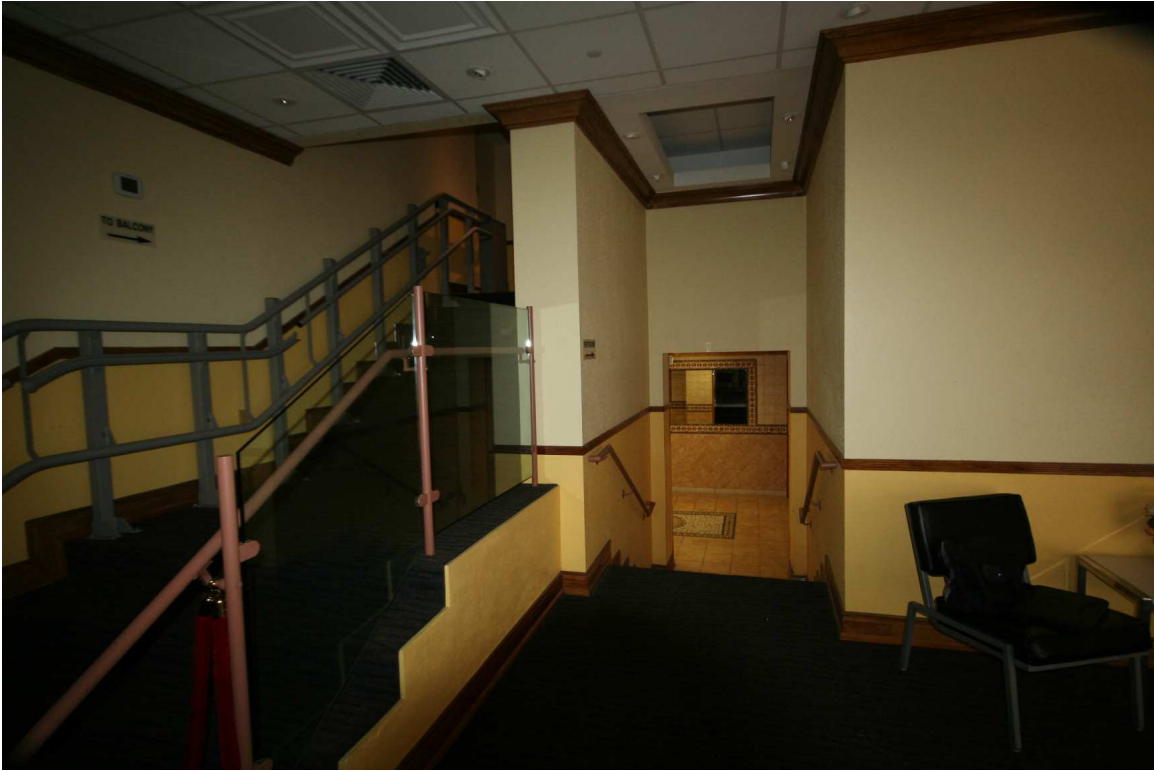
PHOTOGRAPH NO. 9
STEPS FROM LOBBY DOWN TO RESTROOM (& UP TO UPPER AUDITORIUM)

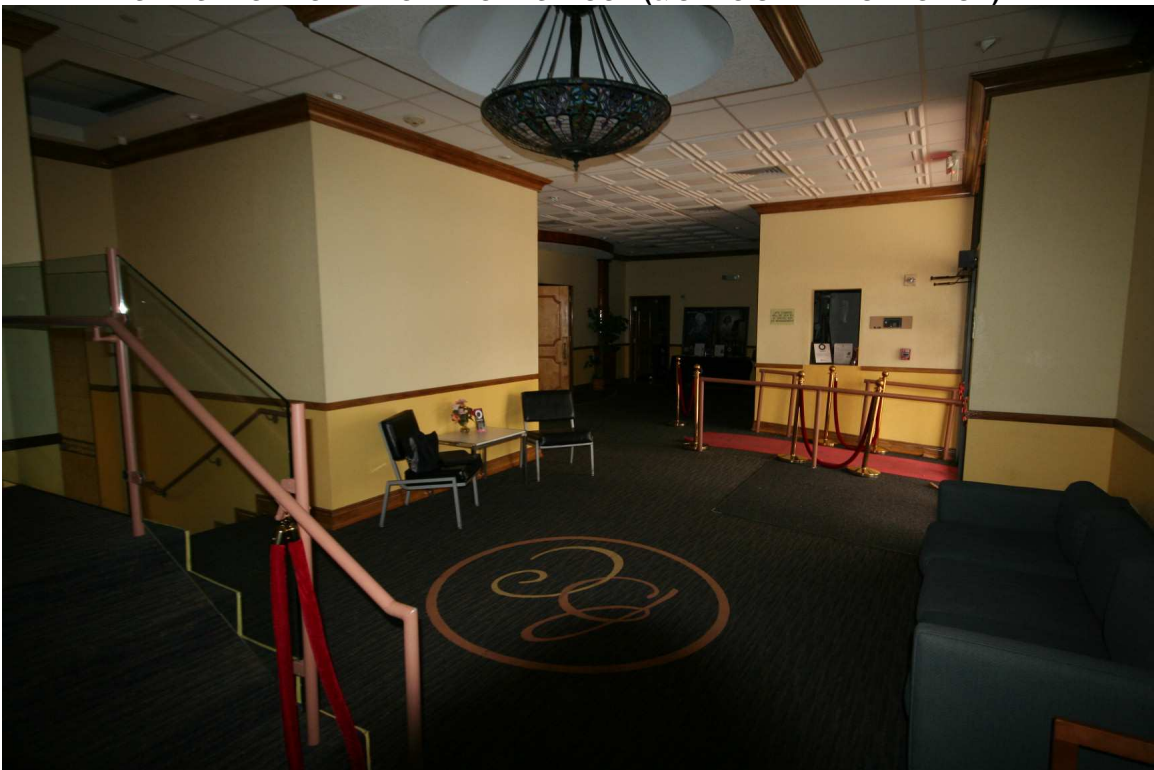
The main lobby entrance to the theater is at the top of the back-of-sidewalk elevation. There is an interior ramp inside the main doors, and the main lobby floor is a few inches higher than the sidewalk. In the southeast area of the lobby, there are steps up to the upper auditorium seating level and steps down to the public restrooms. The floor of the restroom is approximately 2'-1/2 feet lower than the main lobby level. In the absence of specific survey elevations and high water elevations, it appears that the floor of the restroom area and the low points of the unused auditoriums on the west side of the building are significantly below the observed high water elevations during the king tide cycle in October, 2015.

PHOTOGRAPH NO. 10
MAIN LOBBY
(SLIGHT RAMP UP FROM SIDEWALK-LEVEL ENTRY DOORS)
